Life Cycle & Durability Case Study - Rotacaster Wheels

- Test Site:** Wallis Lake Fisherman's Co-operative
- Customer Contacts:** Mr. Noel Gogerly - President - Phone: +61 (0) 428 656 481
Mr. Barry Murray – Floor Supervisor

- Application:** Custom trolley for movement of multiple crates of ice packed fish to and from process area to freezers.
- Normal Loading:** Averaging between 150-200 kg (325-450 lbs)

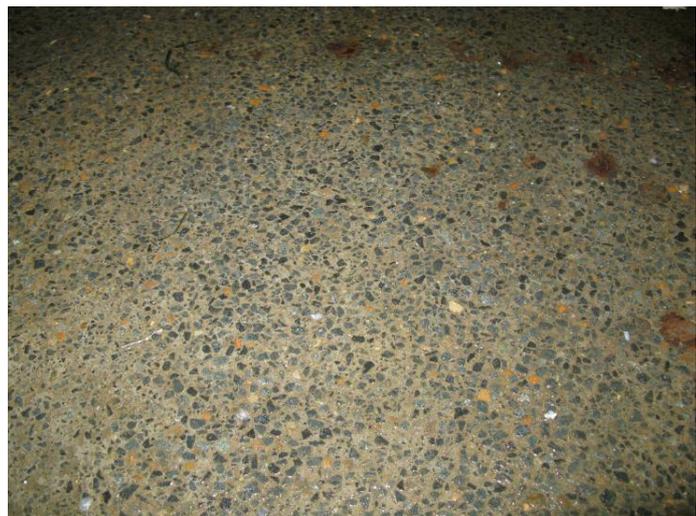
Floor Surface

- Period in use:** 2 ½ years (Oct 05 to March 08)
(Nylon swivel castor replacement – every 6 months)
- Environment:** Coastal location in a highly abrasive and corrosive working environment. The exfoliated (exposed aggregate) floor combined with constant exposure to salt water and sand provided an extremely harsh wear characteristics compared to those normally encountered in most working environments.

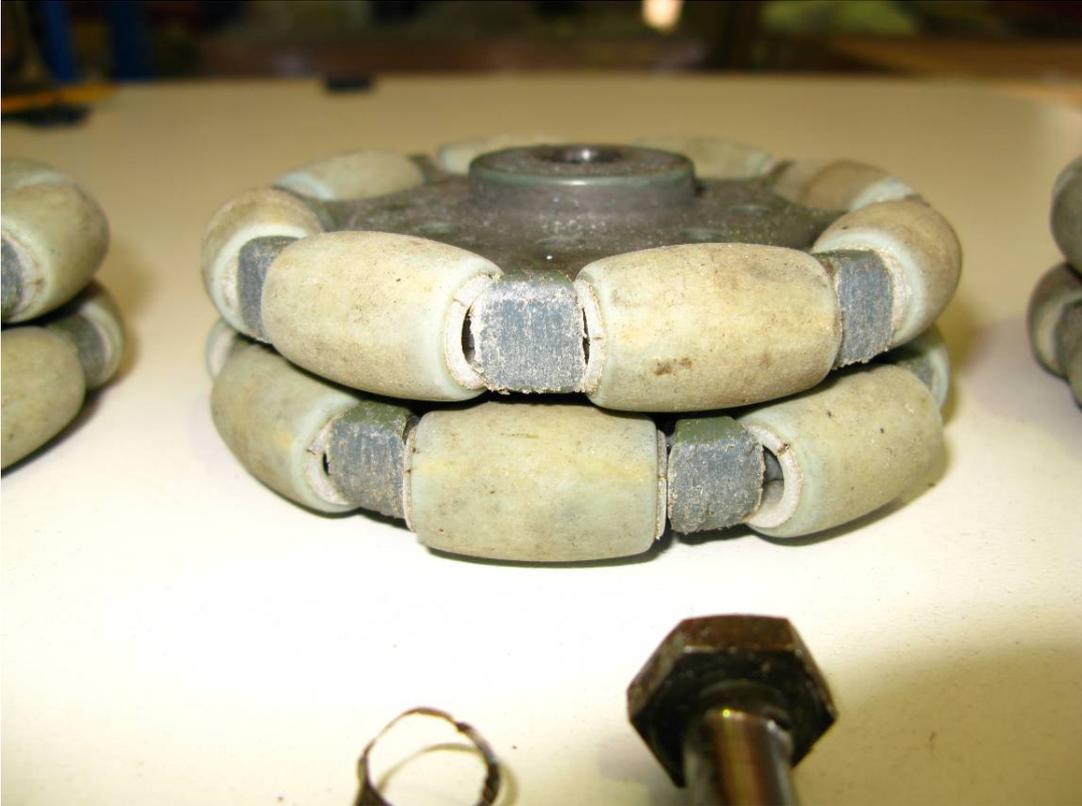
Rear Wheel

The wear patterns and extent seemed to vary between the front and rear wheels with the rear wheels exhibiting the most wear. This was predominantly due to the rear wheels providing the majority of lateral movement for steering i.e. greater sideways use.

There was considerable wear to **the roller (transverse) axles** and the head of the radial support arms of the rollers. On one of the six wheels, one radial support arm had failed. Despite this the trolley was still in service and functioning effectively.

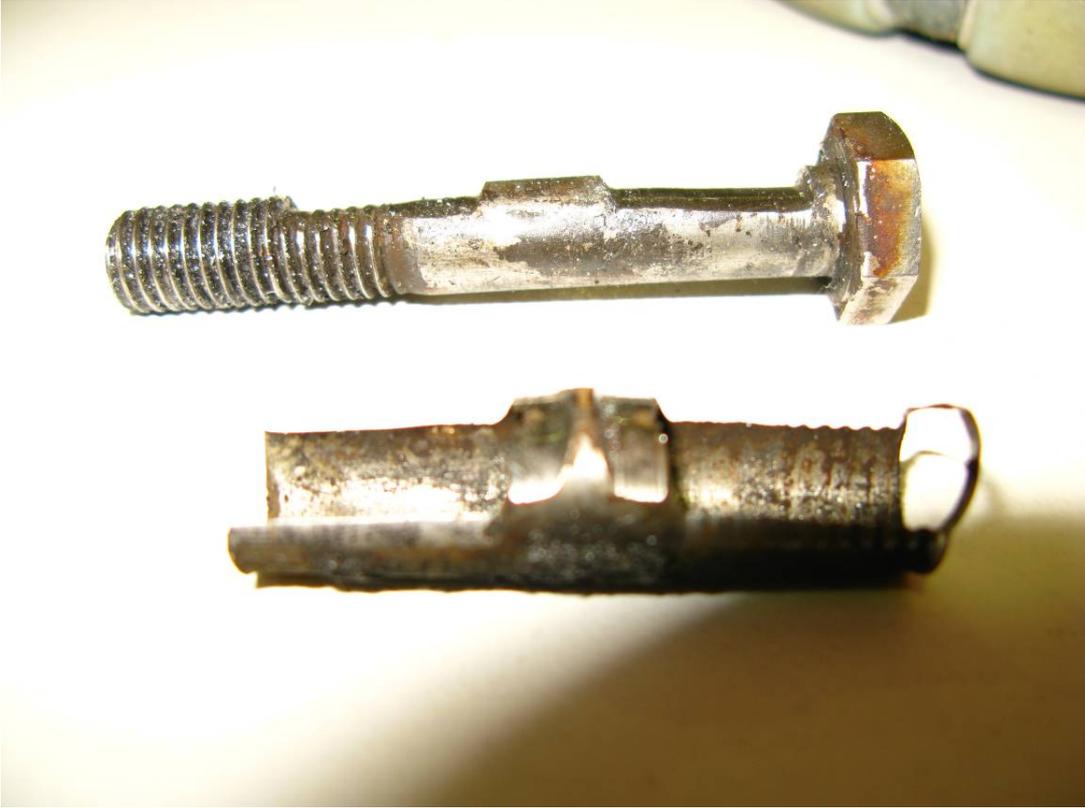
Rear Wheel Axle and Spanner Bush

On disassembling the wheels, there was considerable wear to both the stainless **steel spanner bush and axles**. On a number of samples, the one (1) millimeter wall of the spanner bush had been completely worn away and up to another millimeter into the stainless steel axle.

Neither the **nylon wheel bearings nor the roller bushes** exhibited any substantial wear. On close inspection it was obvious that sand embedment in these elements had made them abrasive rendering the adjacent stainless steel and carillon surfaces to be sacrificial wearing surfaces.
