Life Cycle & Durability Case Study - Rotacaster Wheels

- Test Site:** Wallis Lake Fisherman's Co-operative
- Customer Contacts:** Mr. Noel Gogerly - President - Phone: +61 (0) 428 656 481
Mr. Barry Murray – Floor Supervisor

- Application:** Custom trolley for movement of multiple crates of ice packed fish to and from process area to freezers.
- Normal Loading:** Averaging between 150-200 kg (325-450 lbs)

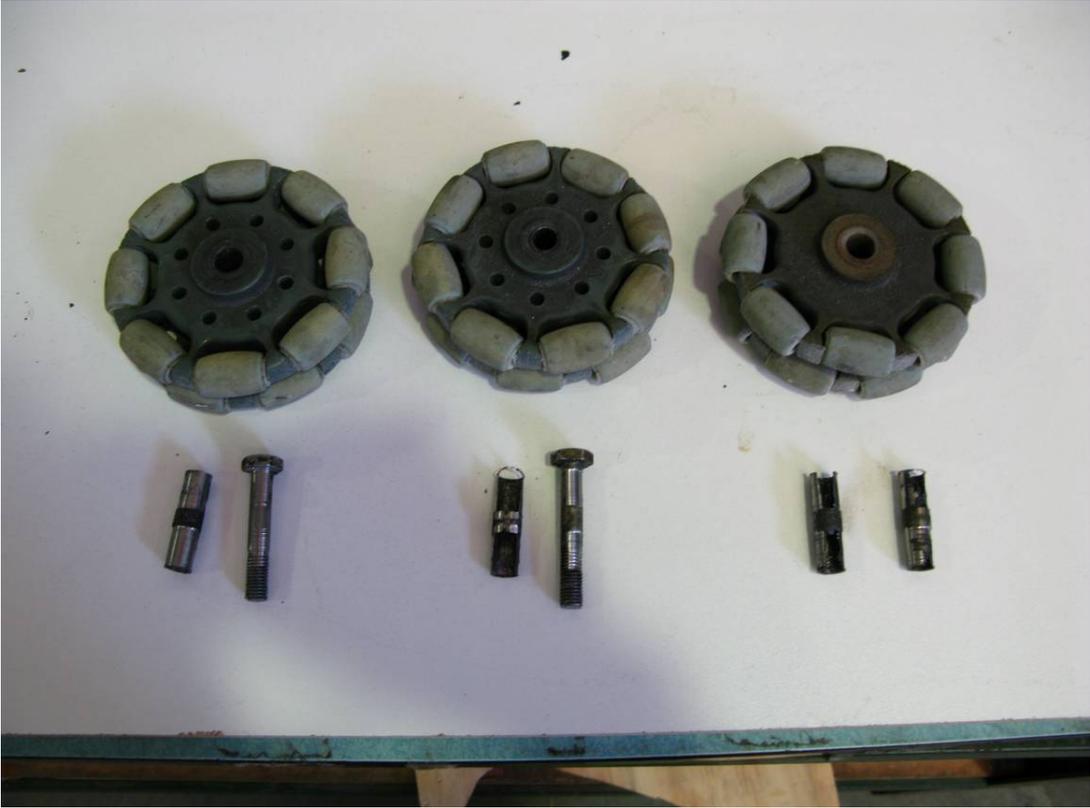
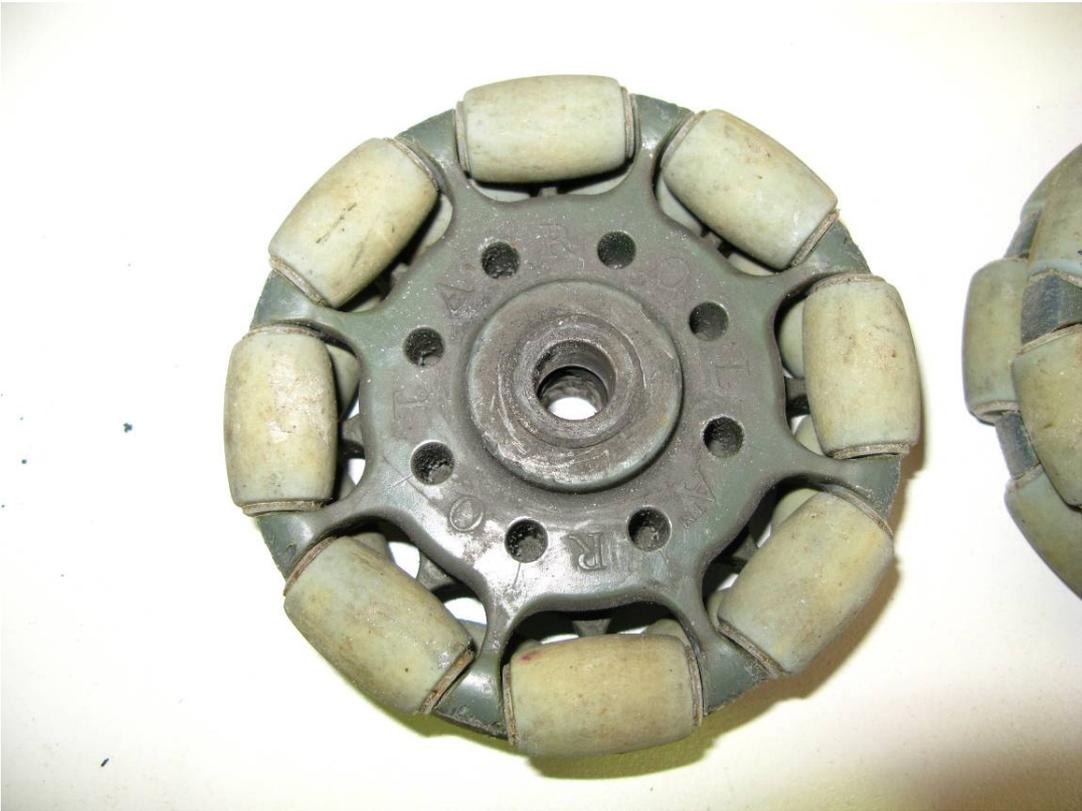
Floor Surface

- Period in use:** 2 ½ years (Oct 05 to March 08)
(Nylon swivel castor replacement – every 6 months)
- Environment:** Coastal location in a highly abrasive and corrosive working environment. The exfoliated (exposed aggregate) floor combined with constant exposure to salt water and sand provided an extremely harsh wear characteristics compared to those normally encountered in most working environments.

The Wallis Lake Fisherman's Co-operative is situated on the harbor inlet to Wallis Lake in the seaside resort of Forster-Tuncurry, NSW, Australia. The naturally corrosive environment combined with the existing floor conditions and the nature of the specific application provided a true challenge to the durability of not only the rotacaster but for any wheel product.
